A SPECIAL “TRAFFIC SAFETY” REPORT

JASBINDER SINGH

SPRING STREET

(dated 9-19-22)

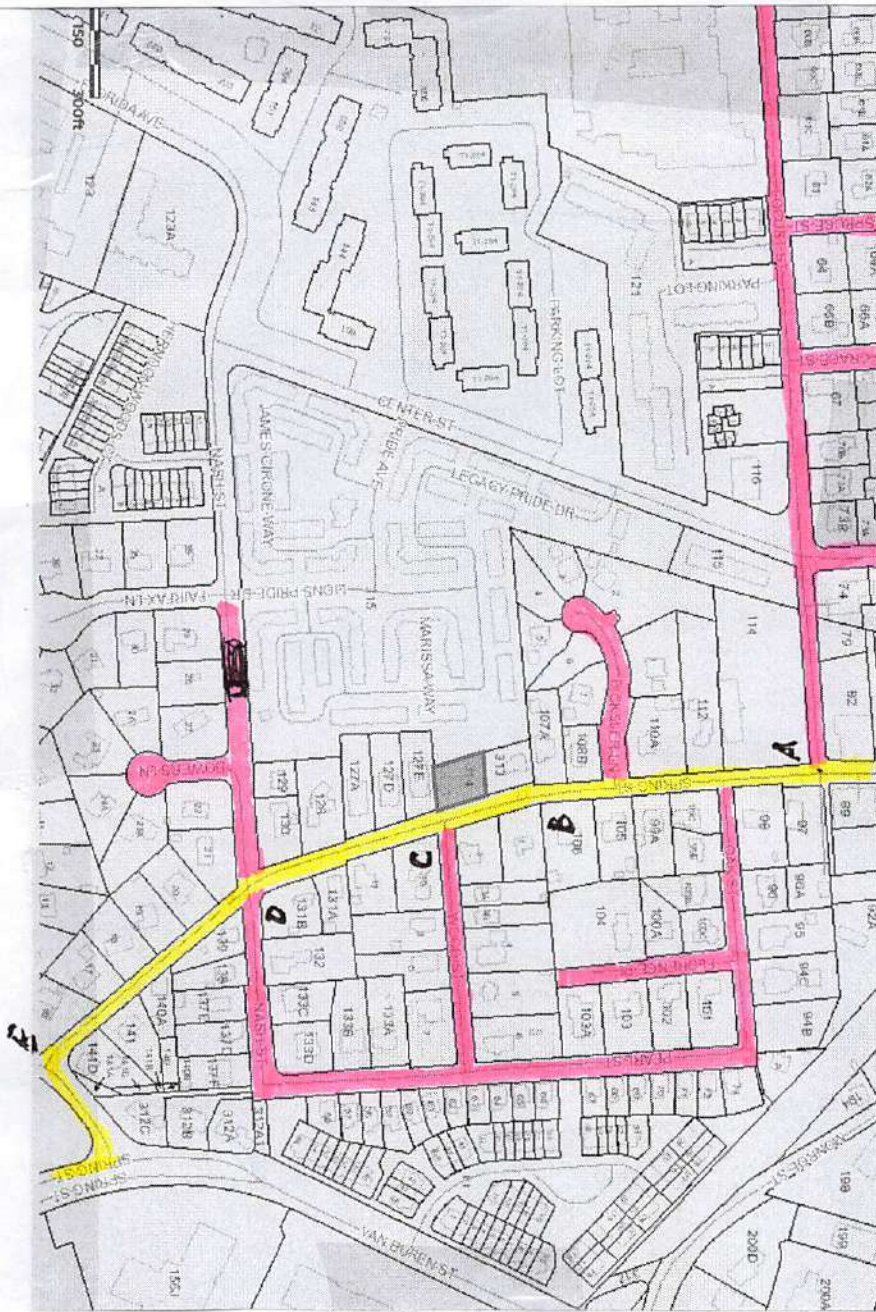
SPRING STREET

1. Inability of Drivers to React to Changes in the Slope and Direction of the Road

About half way between point A and point B, the road begins to rise rapidly and peaks at point B. It also turns somewhat sharply near point B. Consequently, while traveling from Locust, I could not see the road surface on the other side of point B until I had crossed Bicksler Drive. At that point, I had enough sight distance to safely navigate the curve in the road while traveling at 25 mph.

I found it difficult to do so, while traveling at 35 mph. It is reasonable to assume that if I had been impaired in some manner, my reaction to the change in slope and direction would have been much slower and I would have been in substantial danger of losing control of my car.

I believe this is how the latest accident took place. The driver in that case was probably traveling at a speed higher than 35mph and was probably impaired or distracted in some manner. He lost control of his vehicle at the turn and ended up in the front yard of the home located at 631 Spring Street.

A similar (but, not as bad) situation exists, if a driver is traveling from Point E to Point A). The road rises upward between E & D and the driver cannot easily gauge the change in the direction of the road at D until he/she has reached the end of the second to last house in the E-D block (610 Spring Street) or the middle of the next house that borders Nash & Spring Streets. Once again, even though there is a greater sight distance at this location, if a driver is traveling at more than 35 miles per hour, he/she is likely to find it difficult to navigate the curve D (Nash Street). In 2012, a BMW struck the electric pole located at the northeast corner of Nash and Spring Streets. Therefore, in this case also, it is appropriate to post a Stop sign at this location.

- a. this danger cannot be mitigated even if the Town posts a sign (between A & B) that warns drivers of the change in direction and/or the slope of the road at B,
- b. the only solution is to compel drivers to come to a full stop before reaching point B, and
- c. the best place to **post a STOP sign is at Bicksler Lane**

- Install a STOP Sign @ Bicksler Lane
- Install a STOP Sign @ NASH Street

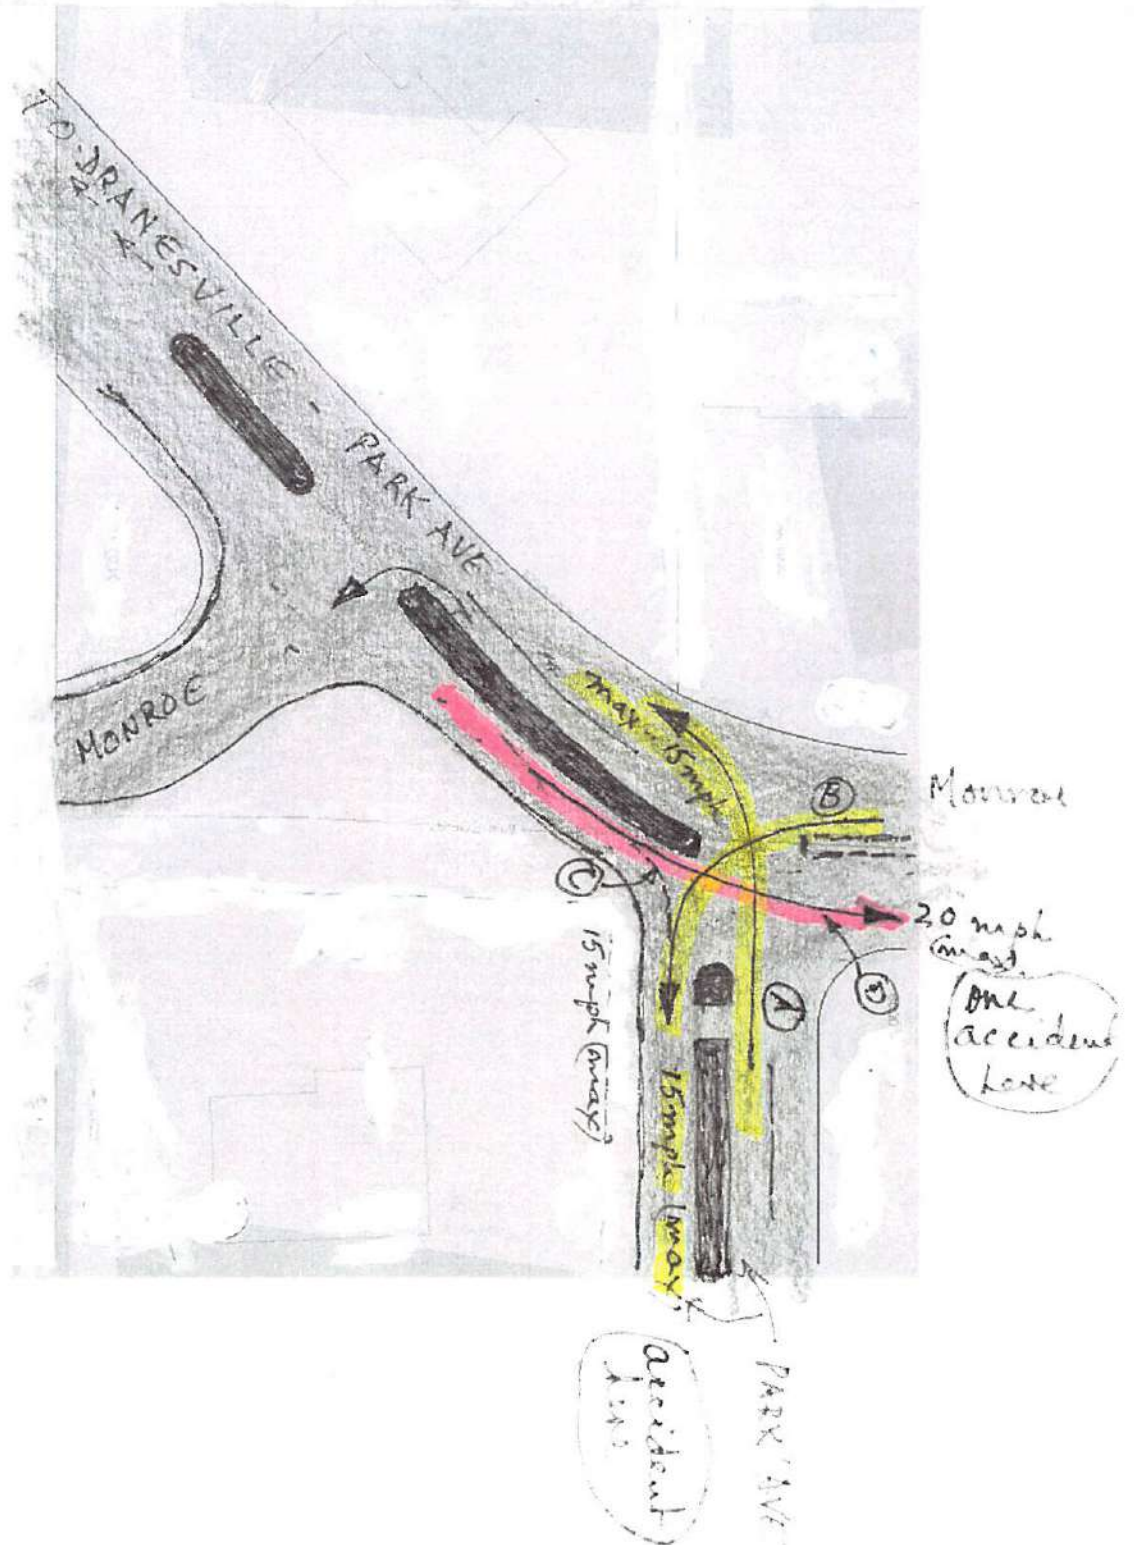
PARK & MONROE

Back in 2014 (?), the Town rebuilt the intersection at Park Ave and Monroe Street. It was a problematic location due to the rather unusual manner in which the two roads meet & exit at this location. First, Park Ave coming from Dranesville takes a 140 degree turn at the intersection. Second, the western part of Monroe Street, shifts downward by about 25 ft at the intersection.

These configurations have restricted the speed of vehicles through this intersection. As the attached Figure shows:

- Vehicles coming from Dranesville and turning on to Park Ave can make the 140 degree turn at a speed of about 15 mph.
- Vehicles coming from Elden Street (on Monroe) and turning south on to Park Ave can also make the 90 degree turn, at best, at 15 mph, and
- Vehicles coming from Dranesville and continuing on to Monroe can make the necessary turn, at best, at 20 mph.

Since the reconstruction in 2014, two “accidents” have taken place. In one case, a vehicle coming from Dranesville and continuing on to Monroe, crashed through the fence of the first house on Park Ave and ended up in its side yard. In the second case, a vehicle coming from Elden Street made a 90 degree turn on to Park Ave at a speed much higher than the safe speed of 15 mph. It bumped into the curb in several places before the driver could control the vehicle.

The Remedy: Currently, only one sign near the intersection suggests that the speed limit is 25 mph, which is the speed limit on the roads approaching the intersection. There is no sign, at or just before the intersection that advises drivers to drive through the intersection at 15mph or less.

The Town should post signs (on the three road segments that come into the intersection) **that contain diagrams of the intersection and advise that the safe speed through the intersection is 15mph.**

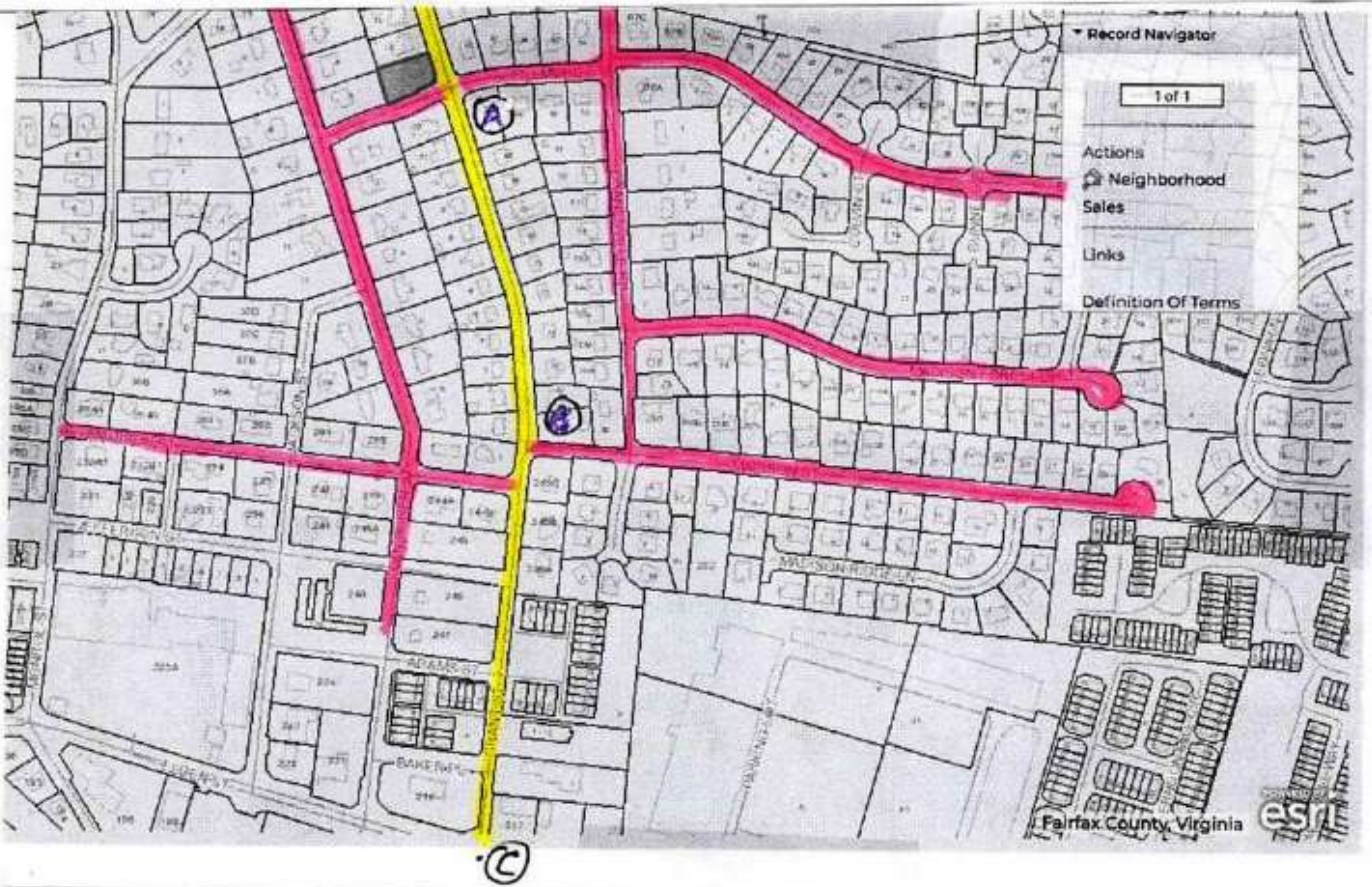
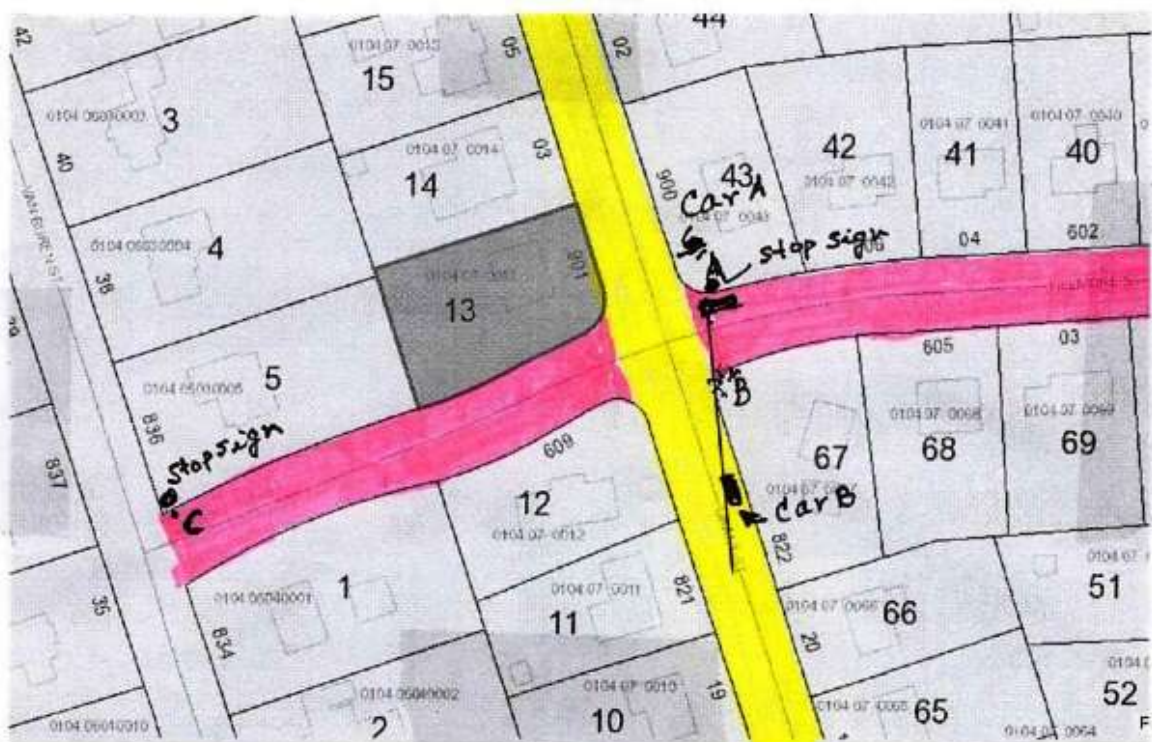
GRANT & FILLMORE

During the last year several major accidents have taken place at this intersection. The owner of the home at the northwest lot has witnessed three of them this year including one in which the car coming traveling fast on Grant **flipped over** the car traveling on Fillmore.

1. **Extremely Short Sight Distances:** A car that has stopped at the Stop Sign on Fillmore (Car A) cannot see the Car B until it has reached within 100 ft of the intersection. Similarly, Car B cannot see Car A unless it has reached within an uncomfortably short distance. The probability of more accidents is high under the current circumstances.
2. **Excessive Speeds:** Some cars traveling on Grant Street, especially those coming from the Elden Street side, travel at excessively high speeds. Some have claimed such cars are driven by those who are employed in Food Delivery business located on Elden Street; however there probably are many reasons for

Remedies: It to make sure that business or other vehicles do not travel through our streets at high speeds. There are several steps the town can take to address this issue at this and other locations. These include:

- a. **Install Stop Signs on Grant Street:** Some consider this a top priority. They want all vehicles traveling on Grant will have to stop at this intersection.
- b. **Work with businesses to ensure that their delivery employees are trained properly and that employers are accountable**
- c. **Install cameras at the intersection and Paint Cross Walks for school children**

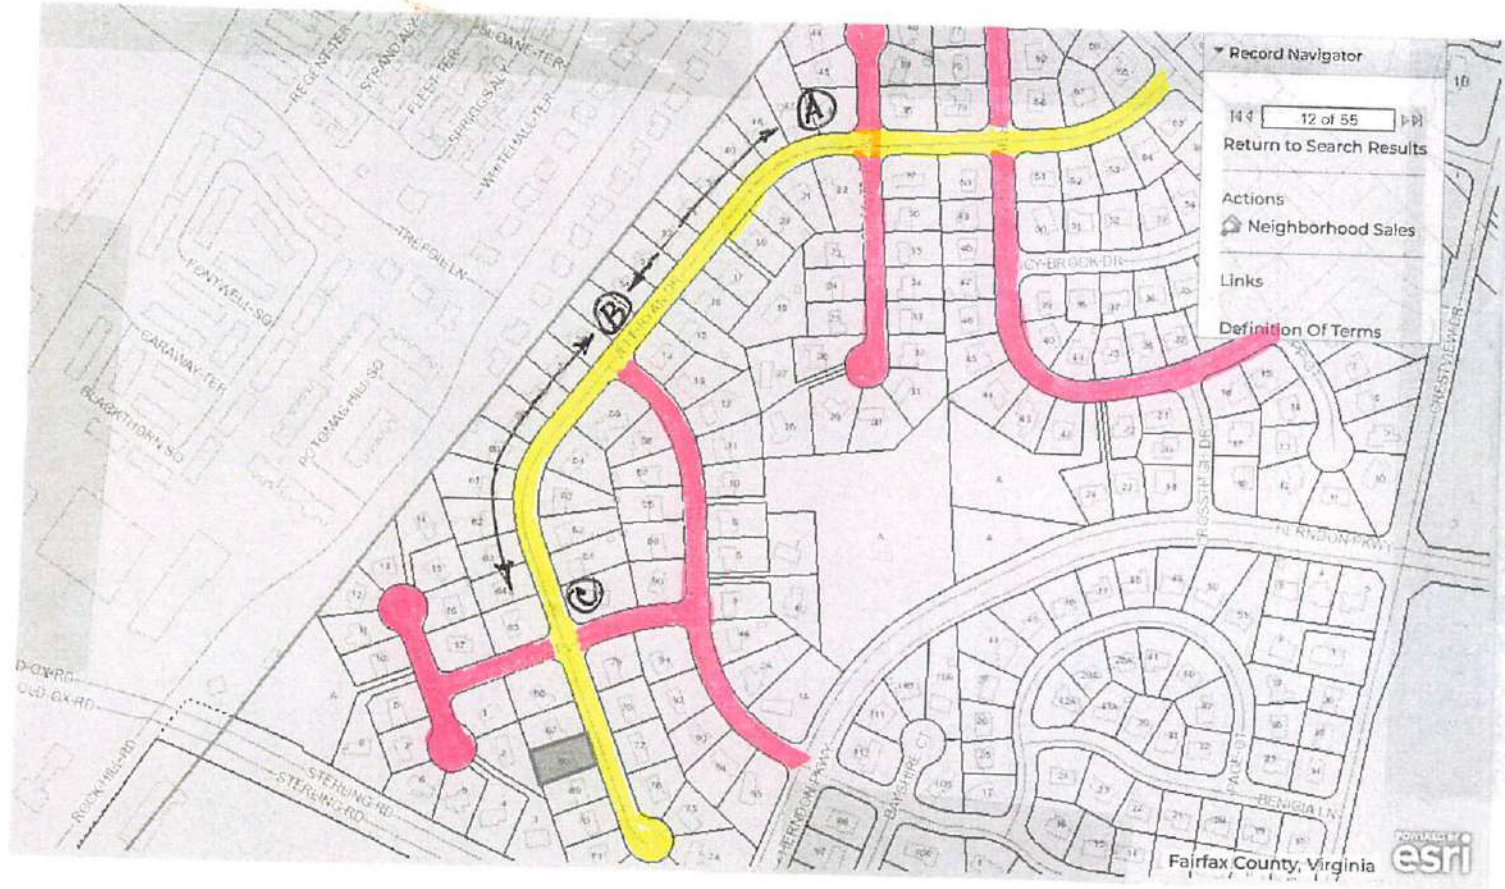
JEFF RYAN DR.

The slope of Jeff Ryan road begins to increase at Cuttermill Court, first slowly and then rapidly. A car traveling at 10 mph near Cuttermill (Point A on the accompanying chart) can attain a speed of about 35-40 miles per hour by the time it reaches Point B Bayshire Lane and about 50 miles per hour when it reaches Point C, even when the driver takes his foot off the pedal.

Residents of the area and visitors park along this stretch of the road every day. Drivers traveling half way between Point A and Point B often cannot see anyone standing, sitting or playing in front of or near the cars. There is an ever-present danger of someone stepping into the travel lane. Further, residents who live half way between Point B and Point C (considered the high-speed area) in recent years have complained loudly about the danger of accidents. They often fear for their lives and for potential damage to their property. In spite of complaints since at least 2016 (when I did a study of the intersection at Bayshire), the town has stifled their requests for a STOP sign at Bayshire. Why, some of the residents ask? **So, little cost and so much resistance.**
